Mineral Ridge Technical Review Panel

**MINERAL RIDGE DAM, OH
TECHNICAL REVIEW PANEL MEETING
DECEMBER 18-20, 2017 – TRP REPORT #01**

Mineral Ridge Dam was designed before and during 1928 with construction completed in 1930. The maximum height of the dam is about 60 feet and the reservoir impounded by the dam is 7 miles long, 2,109 acres in area, and is estimated to contain over 11 billion gallons of water. Mineral Ridge Dam is the sole drinking water source for the Mahoning Valley Sanitary District (MVSD), which supplies water to approximately 220,000 people in Mahoning and Trumbull Counties, Ohio, including the cities of Youngstown and Niles.

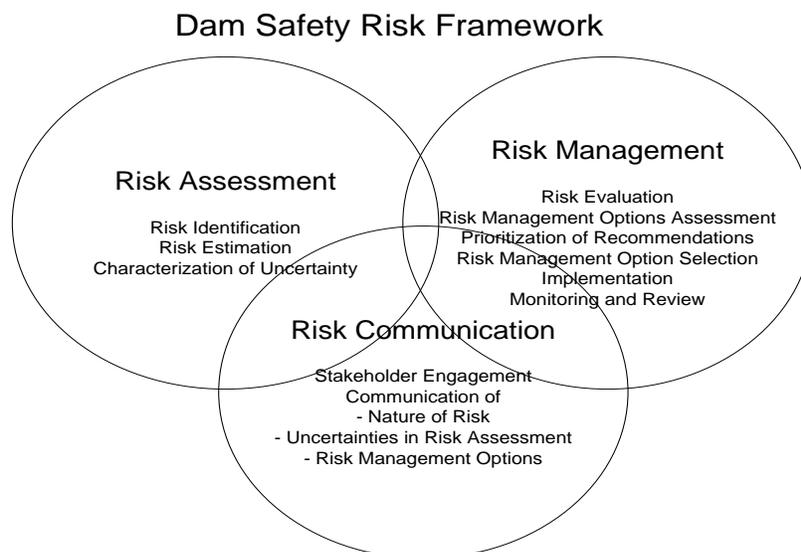
Dam Safety consists of three primary components as depicted in [Figure 1](#).

[Figure 1](#). Dam Safety Risk Framework

Regarding the three primary components of Dam Safety (Figure 1):

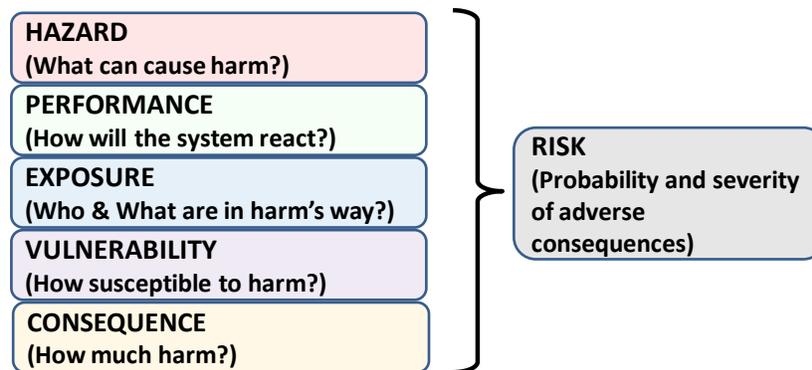
The components of risk are depicted in Figure 2.

Figure 2. Components of risk in dam safety analyses.
